Extension Pins and Log Load Securing Requirements

NOGGIN INC2682 10/08/20 – Medical Treatment Injury.

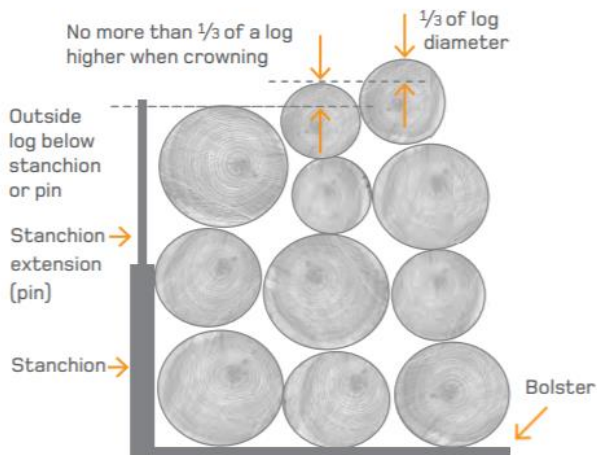
- No part of the **outside** logs of the load shall be loaded above the top of the stanchions or the stanchion extensions.
- Logs loaded in the middle of the load **shall not have more than 1/3 of the diameter** of the log above the adjacent logs.
- The top of the load shall be rounded so that the load-securing device will contact as many logs as possible – see log loading graphic.

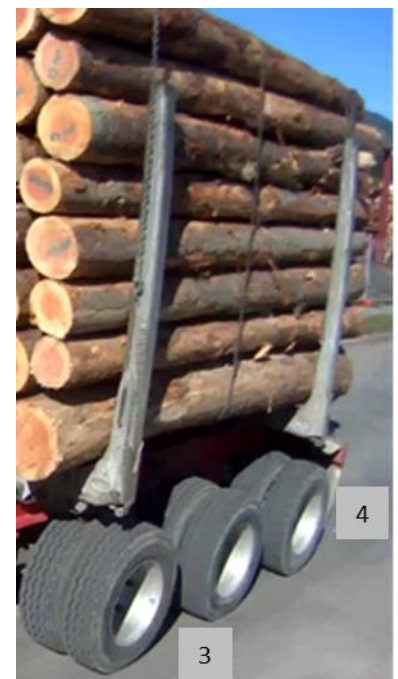
Description – while unchaining the load a driver released the tension on the chains before proceeding to the passenger side of the trailer to hang them up. CCTV footage shows the driver stowing the chain at bolster 4 before moving forward to bolster 3 when the top-log (as pictured) rolled off the bunk. It struck the driver on the shoulder and side of the head, causing minor cuts and heavy bruising.

NOTE: The image is taken as the truck arrives at the Port, as captured by security camera. The extension pin is visible on bolster 4 but not visible on bolster 3, however it was not lowered by the driver. The log that fell is the top-most log pictured in the image. As situated, it is sitting on top of the ‘outside log’ – please compare with the log loading graphic.

The truck was fitted with Patchell bolsters, specifically engineered and time proven. However, the investigation revealed that the extension pins were retrofitted by the original owner of the vehicle, and someone other than Patchells. **Incorrect installation** has allowed the pin to extend beyond its design limit and therefore not lock into place correctly. It has subsequently dropped down into the bolster, at some time during transit.

1. When using new or used equipment both Owners and Operators have duties to ensure that devices are properly installed, can activate or lock-out correctly, and be used safely.
2. PCBU’s that design, manufacture, import, supply and install plant, substances, or structures must ensure such are safe to use and fit for purpose – [HSW Act 2015 s. 36–43](#).
3. Immediately report faulty equipment taking it out of service until corrected or repaired.
4. Use this alert as an occasion to review all safety devices **especially on extension pins**.
