## Chain-shot Hazard ...Reducing the Risk!

# PPE – Is Yours Up to Scratch?

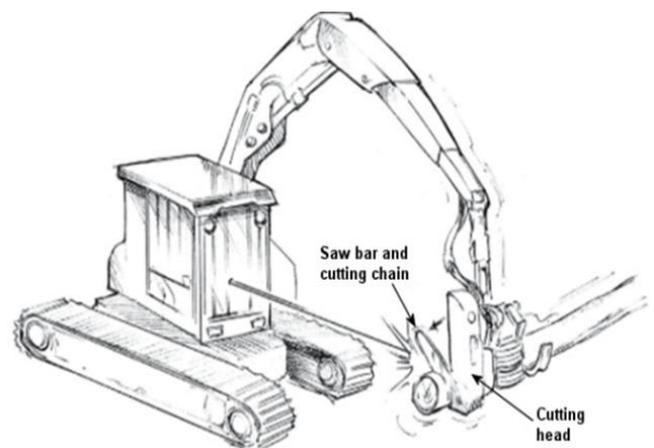
**Our own experience is that chain shot occurs often enough to make this matter our concern...** In a very recent incident (October 2015), a saw-chain broke during processing, sending pieces of the chain into the machine’s front window. Fortunately, the crew’s **chain-shot plan** had fully isolated the machine from ground-workers and the polycarbonate front screen, 22mm thick, protected the

- Establish a **chain-shot exclusion zone** using marker cones or a goal-post system. Draw a plan of the exclusion zone and **absolutely prohibit all people and machines from entry**.
- **Use signage to alert** everyone to this hazard, the exclusion zone, and to stay clear.
- **Install 19mm polycarbonate/acrylic** as front screen protection. This is a **minimum** thickness and mandatory for all mechanised harvesters whether they process or fell.
- If any other machine must (even temporarily) operate within a ‘chain-shot’ exclusion zone, then either **plan for harvester to pause** or ensure that machine is protected.
- **Preventive maintenance** – reduce the likelihood of **the chain breaking** in the first place.
- Install, inspect and maintain a purpose built **chain catcher** (deflector).

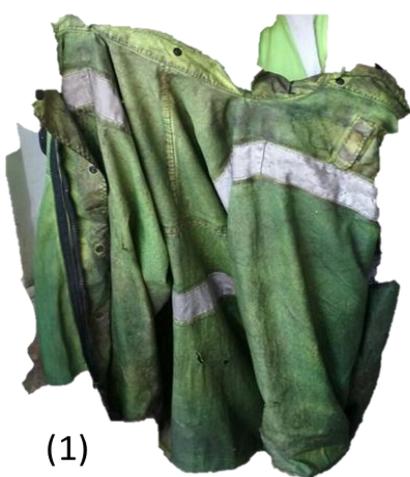
- Figure (1) – Shows Hi-Vis clothing that has clearly degraded, through use, to the point that the garment no longer serves as an ‘**alert to a worker’s presence**’.
- Figure (2) – Displays part of a Hi-Vis jacket fitted with ‘**retro-reflective**’ tape. This garment, photographed in poor light, is near new. Can you notice the difference that the **Day/Night (D/N) tape** makes, as it catches and reflects a light source?
- Figure (3) – Shows a Level 4 chainsaw (cut-resistant) boot, manufactured in January 2014. It did not prevent a laceration to the operators’ foot (see Safety Bulletin #92).

- Hi-Vis clothing shall display AS/NZS 4602 or NZFOA labelling and be, in all cases 'Class D/N' i.e. having 24-hour (both day and night) visibility.  
**NB:** This includes wet weather/rainwear.
- Hi-Vis clothing shall be checked regularly (a minimum daily) against an approved swatch (or chart) and replaced immediately when non-compliant.
- Chainsaw cut-resistant boots shall be replaced when cut or holed.
- Chainsaw cut-resistant legwear (chaps) shall have the purchase date recorded either on the garment or in the PPE register and replaced after six months continuous (daily<sup>2</sup>) use.

The [BPG for Personal Protective Equipment](#) on **page 3** notes, “a hi-vis garment that is dirty or faded will be less obvious to other workers and thus will provide less protection to the wearer. Garments should be washed regularly to preserve their high visibility. If washing does not restore high visibility, the garment should be replaced.”

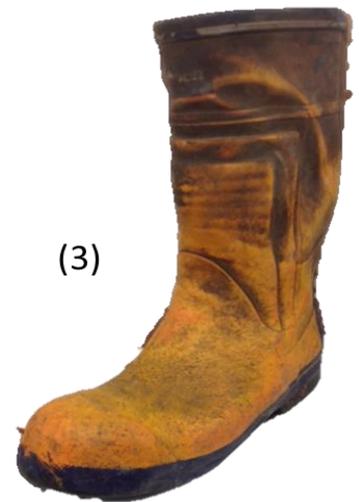
(3)

The technical analysis report notes, “...the sole has worn down to the upper in parts and the upper rubber has suffered extensive cuts across the toe, vamp and forefoot.” This allowed “**moisture damage to the protection system and delamination.**” In short, this “...boot was compromised...” and no longer able to fulfil its protective function!

On **page 7**, the BPG notes, “Leather boots should be treated with a water resistant seal before being worn” ...and “every 2-3 months” thereafter. Importantly it notes that “any work boot, **but particularly chainsaw cut-resistant gumboots, should be replaced when cut.** A cut gumboot does not provide adequate protection and can be a hazard in itself if it catches on something.”
