Are the wheels coming off?

OPS – Operator Protective Structures

Incident Raises Questions

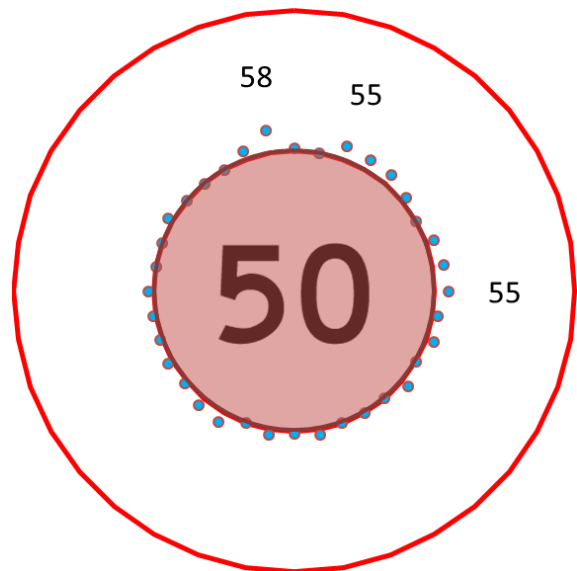
The graph to the side shows a small snapshot of forest driving speeds, recently measured by an independent contractor.

The picture is slightly different from the previous snapshot when most of the dots were located inside the 50kph sign – indicating that driving speeds were mostly clocked at less than 50kph (in a range between 45 – 48kph). This graph shows a slightly different picture – with most of the speed points either on 50 or slightly over, and some definite over-speeds!

This graph shows a **small adjustment** may be required! Try 'recalibrating' – driving a **few points under** the limit.

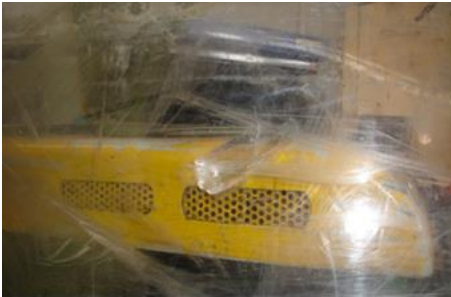
Description: A tethered feller buncher operator was walking the machine up a hill when the 21mm poly-carbonate screen dislodged from its frame and fell backwards into the cab, hitting the operator on his head. This caused a laceration that required stitches.

Investigation: The investigation found that the nylon rollers that held the window in the track to allow the window to open were no longer fitted. The most likely cause of them missing would have been vibration given the front window had not been opened for some time. With the rollers missing there was extra play in the mounting of the window. This steep angle of the slope plus forward motion allowed the window to drop out from the top mounts and to come forward on to the operator.

- Whether fitted after-market or factory fitted, OPS on forestry machinery must meet and remain compliant to the standards.
- Compliance shall in all cases be measured against the [ACOP for Operator Protective Structures on Self Propelled Mobile Mechanical Plant](#) (ACOP).

- Are regularly and thoroughly inspected to determine if the OPS and guarding still meet the standards for the work intended. Any machine not meeting these criteria must be **taken out-of-service** until such time it does.

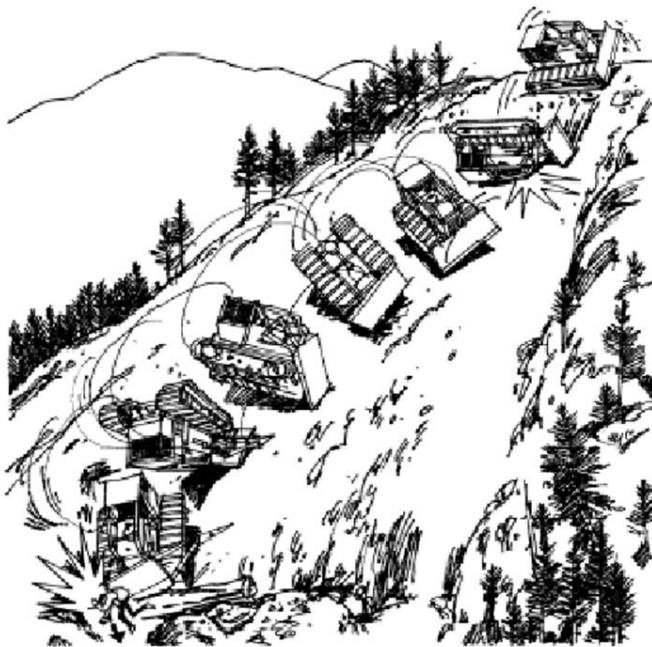
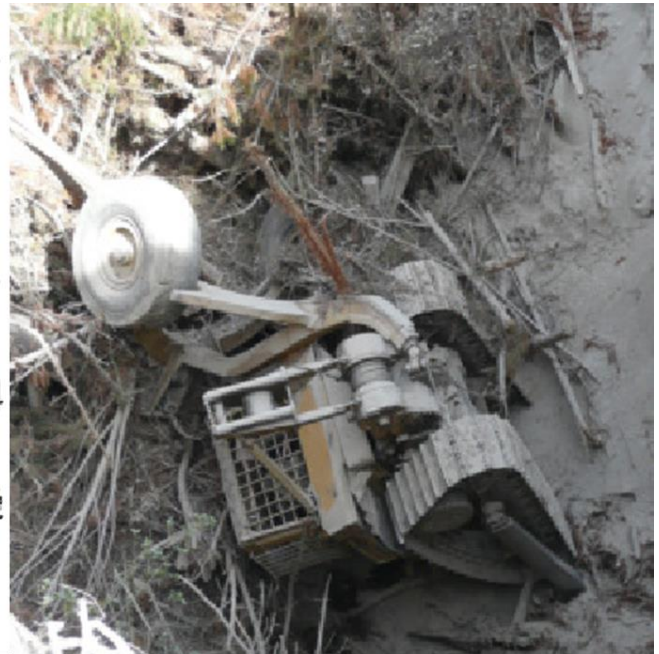
Machine Rollovers – What’s Going On?

The machines were working on moderate to steep slopes meaning that the operators should have been operating the machine under a ‘steep slope policy’. Such a policy ensures that machine operators take adequate time to properly assess ground conditions and the terrain features they will be working on. In two of the cases the operators carried out work without proper planning and communication with the crew foreman. Completing a proper risk assessment, using the forms and process found in the PF Olsen **Safe OP – Working Machinery on Slopes** would most likely have prevented the rollovers!
