Mobile Plant Escape Hatches?

Is Your Hatch in Working Order?

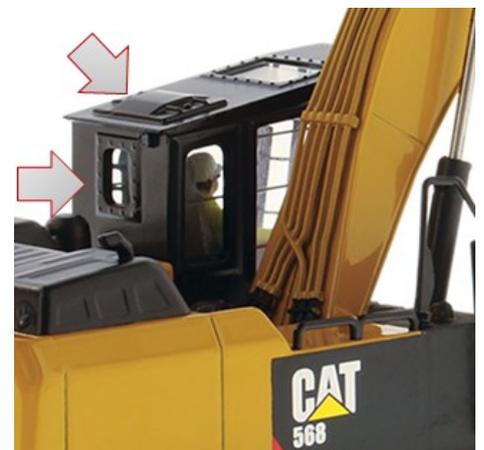
FIPS # 8529 “...As the operator walked the machine... it slipped sideways (on Rhyolite) a few metres and tipped over on to its side.” “...After the rollover incident the crew found that the bolts on the escape hatch had rusted shut making it unusable...”

Check Your Hatches – Each Shift!

Operators should check hatches before each shift taking care to clear away any debris. Bent or damaged hatches, corrosion or damaged seals, over tight bolts, or even heavy repainting can make escape hatches difficult or impossible to open. Check that the external cab (OPS) does not block the hatch especially following minor damage or modifications. It is a good idea to document these checks in the record keeping system.

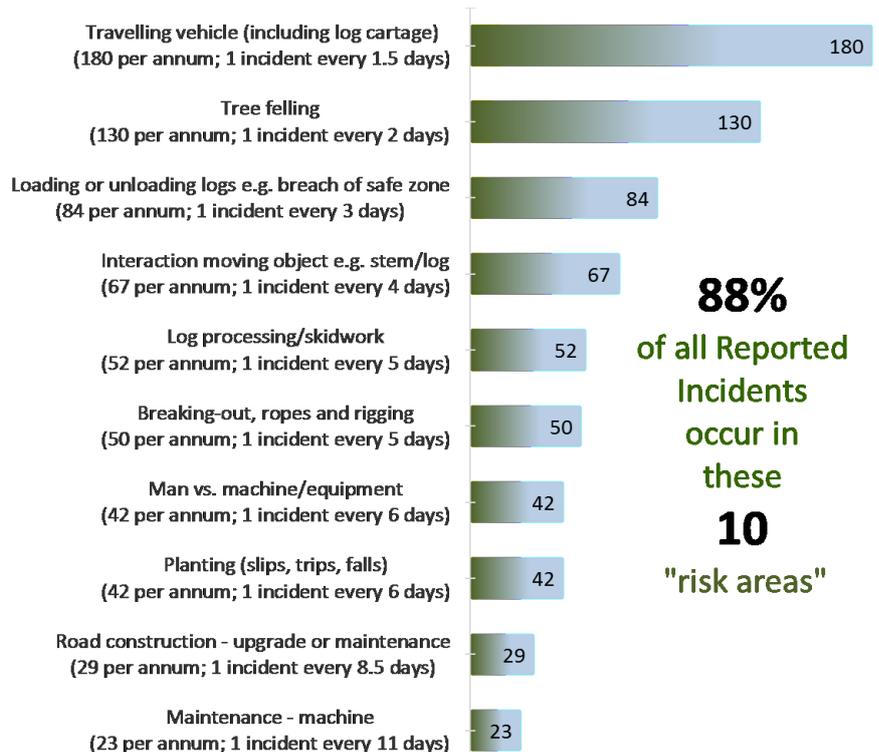
88%
of all Reported Incidents occur in these **10** "risk areas"

Total Number of Incidents (by category) p/a

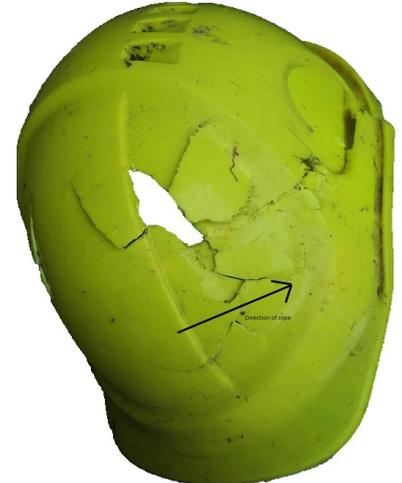
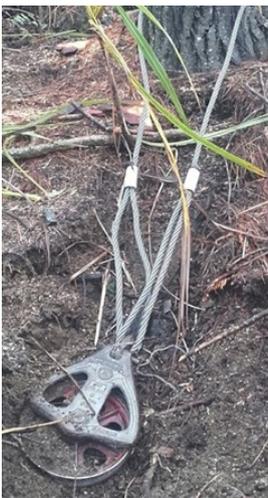
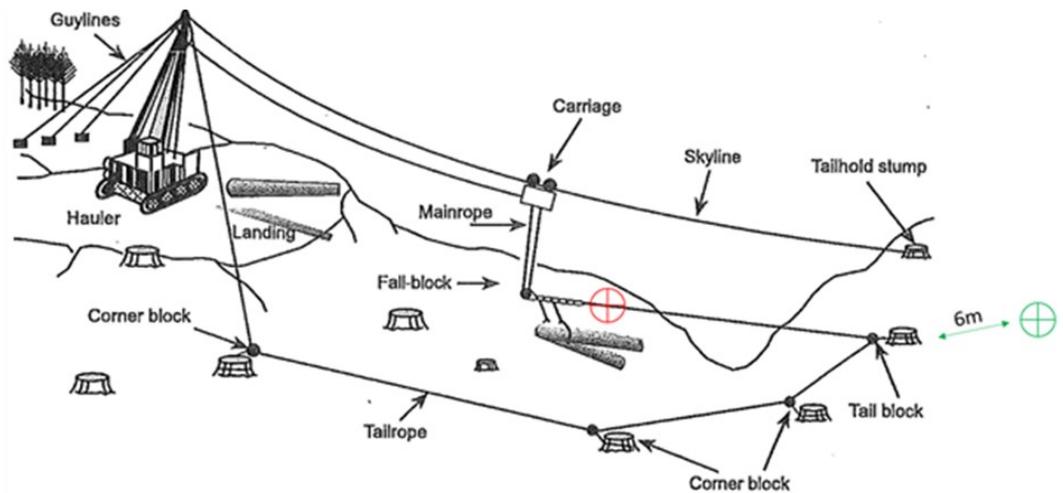
A breaker-out had moved to the designated safe retreat position, which was 6 meters behind the tail block (see image below). During the in-haul, the tail rope broke, fell to the ground and started coiling up-hill.

As the rope moved through the block, it changed its line and direction to where the breaker-out was standing. Protecting himself, he lowered his head and the rope connected his hardhat knocking the rim down causing fractures in his face.

NOTE: The red cross indicates the approximate location of the break in the tail-rope and the green cross the approximate location of the breaker-out when struck.

The investigation showed the system, equipment and hauler setup to be compliant. The main rope had no signs of fatigue both on the drum and in the area of the breakage. The tension monitor was away for recalibration at the time, however, there was no evidence of overloading discovered. The breaker-out was fully qualified (1258). He can thank his hardhat for saving him from more serious injuries (actually, the third time a hardhat has saved a worker this year). While there were no breaches of best practice, or rules, PF Olsen’s Zero Tolerance Committee (ZTC) is currently reviewing whether a ‘certified rope inspection’ would be necessary for all ropes aged between 12-18 months. Secondly, if the Company should specify the position a breaker-out would stand in relation to a working block. It will report on its findings shortly.
