# A Safety Message from the CEO

# Guarding Those Moving Parts!

# Maintenance – Always a Risk!

# Chainsaw Cuts – Never Pretty!

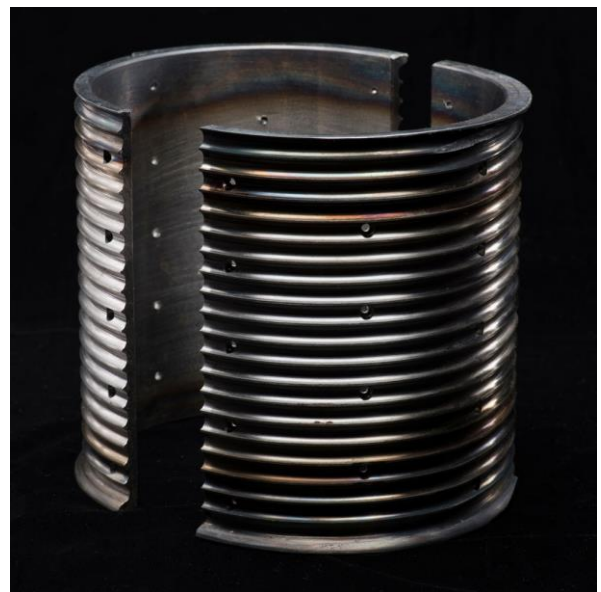
Source: 3D Industrial Engineering

Extend the life of wire rope by equipping winch drums with SpoolPro® Grooved Drums and Sleeves. SpoolPro®’s unique groove pattern allows wire rope to wind straight onto the drum (parallel to flanges) reducing wear on the rope, making it safer to use winch systems and limiting downtime. Follow [SpoolPro® on Facebook](#) for regular updates.

- Less time and labour needed to wind the rope onto the drum.
- Less man machine interaction, improving safety, and
- Reduced wear on the ropes, providing up to four months extra utilisation.

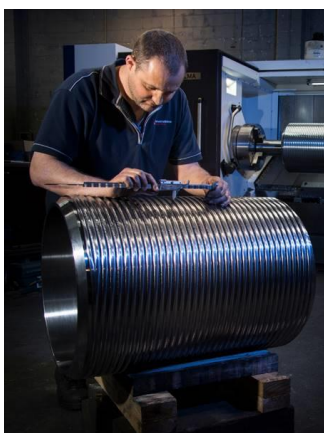
**YouTube**  
[Fitting SpoolPro® Split Sleeves.](#)  
[SpoolPro® At Speed – Real Time Footage](#)

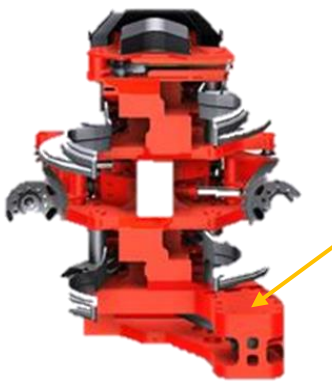
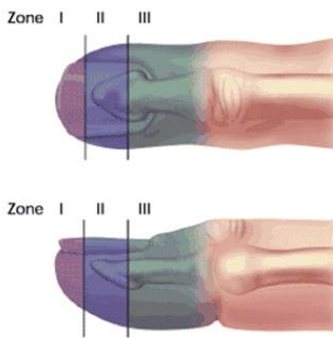
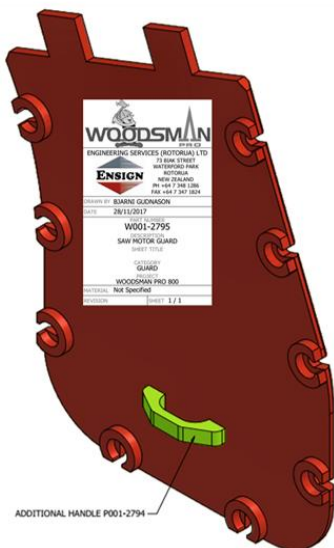
A qualified machine operator (a crew foreman) and the crew mechanic were lifting off the main saw box cover completing a routine task. They were trying to find a persistent oil leak in the processor head and had been working on the 800-series machine for approximately 2 hours. The cover (weighing 15kg) slipped from the operator’s left hand dropping onto his right-hand index finger.

**Design fault** – causing those completing maintenance to work in a manner that could cause injury. Unlike more recent models the 800-series machine did not have handles on its saw-box cover. Typically, screwdrivers would be used to lever off the saw-box cover (see – yellow arrow), then two people would manually lift it out and off, in this case using fingertips. Woodsman has subsequently produced a handle (see – green) for retro-fitting, [assembly instructions, a safety bulletin](#)<sup>1</sup> and a training package.

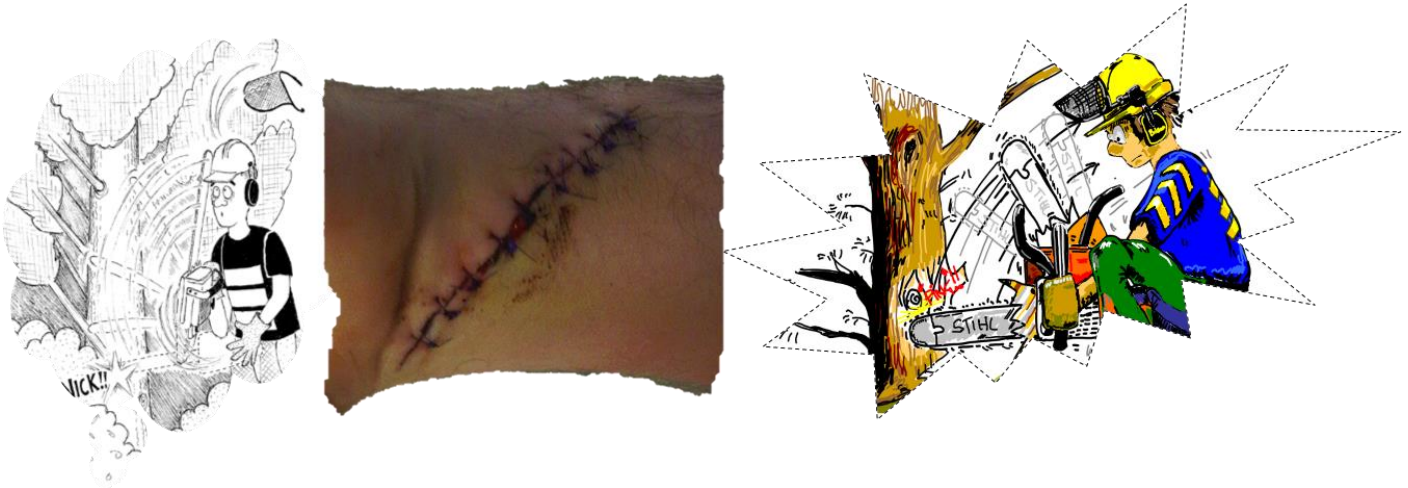
**Background to Noggin INC570 22/11/17** – A tree feller was trimming branches when the stem suddenly moved causing him to lose his footing and balance. His wrist then made contact with the spinning chain severing two tendons.

**Immediate and Root Cause Factors** – In this incident, a moving stem caused the chainsaw operator to lose his balance. This occurred due to the need to manually trim the larger branches.

- Ensure that stem placement allows for sufficient room to work – see **ACOP rule 13.2.3!**
- If stems appear to be unstable, direct a machine to reposition them.
- Hold the saw firmly with both hands and use the correct stance and work techniques.
- Routinely check the condition of protective equipment (PPE) and chainsaw safety devices.

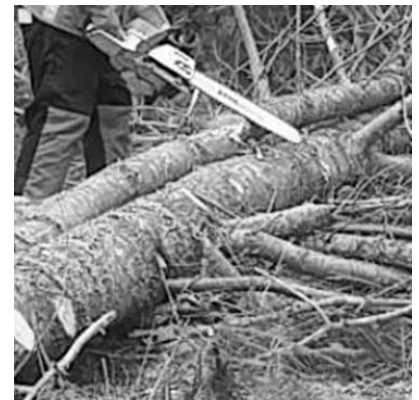
**Injuries, First Aid and Medical Treatment** – The observer immediately applied first aid stopping blood-flow with a tourniquet. The injured tree feller was then driven to Hospital where he was assessed and operated on. His wrist will remain in a plaster cast for 6 weeks at which time we hope he will be healed and ready to return to light work.

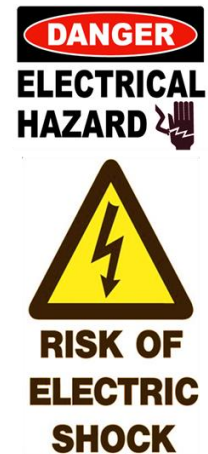
**Description for Noggin INC511 31/10/17** – During mechanised felling a tree snapped off the stump and fell over live power lines leaving the live lines across a public road.

- Inadequate warning system – the fall hazard zone (FHZ) had not been marked.
- The ‘Live Line’ form (linked to the Company Safe Op) had not been correctly completed. Rather than working through the hierarchy of controls we accepted the Network Owner’s ‘Close Work Permit’ as a licence to operate without all appropriate controls in place.
- The Safe Op directs that the FHZ distance be measured by using the height of the tallest tree not the mean tree height, as in this case.
- Inadequate and untimely communications with the Network Operator – meaning that the lines could not be de-livened.
- The operator was also operating under ‘upset conditions’ thinking about a family member.

Live power lines are a hazard with high risk of serious injury or death, and anyone working around them must follow the Safe Op! Please also be aware that WorkSafe NZ has recently published its own guidance document – **A Practice Framework and Operational Guidance**<sup>2</sup>.
