Guarding Those Moving Parts!

Background – Noggin INC458 9/10/17

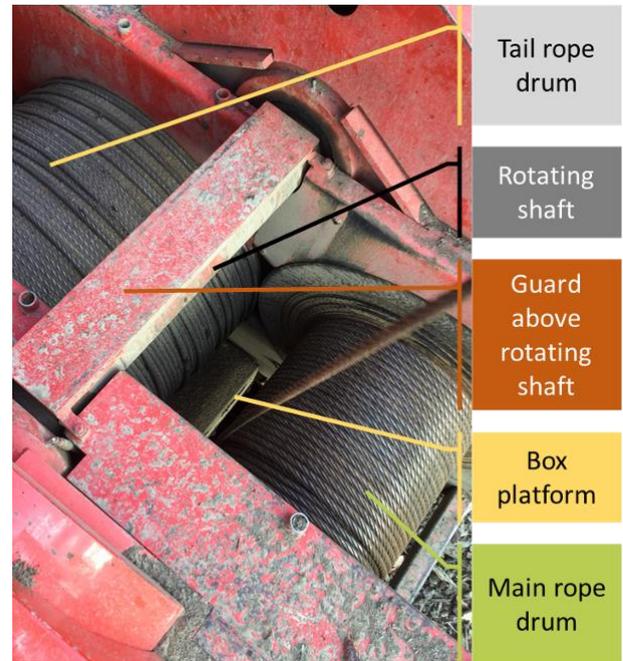
A worker was standing between the tail and main rope drums on what is described as a box platform. He was assisting as the hauler was winding on a new tail rope and leaned back onto the guarding, which was positioned over a rotating shaft.

In this position his Hi-Viz vest entered the gap between the shaft and the guard and winding around the shaft pulled him in toward it. Fortunately, he was able to signal the hauler operator who put the machine into neutral, then in reverse to release the vest and prevent serious harm!

Three very experienced hauler contractors reviewed this incident and each concluded that the worker concerned should never have been standing on the platform between the drums. However, workers at the site considered this to be a safe position to the point where they had discussed “...removing the guard when standing on the box platform”!

- [] No loose clothing during any operation involving rope guidance onto hauler drums.
- [] No standing or crouching inside cavities i.e. below the top level of the drums where a worker would be exposed to a risk of being pulled into the drum or the winding ropes.
- [] Cover access routes and work platforms with non-slip material.
- [] Only use the recommended (or manufacturer provided) tools to guide the ropes onto the drums e.g. guiding staves.
- [] Never remove any of the installed guarding – on any machine for that matter.
- [] Install a lagged drum sleeve (grooved drum) – a new innovation discussed on page 3.

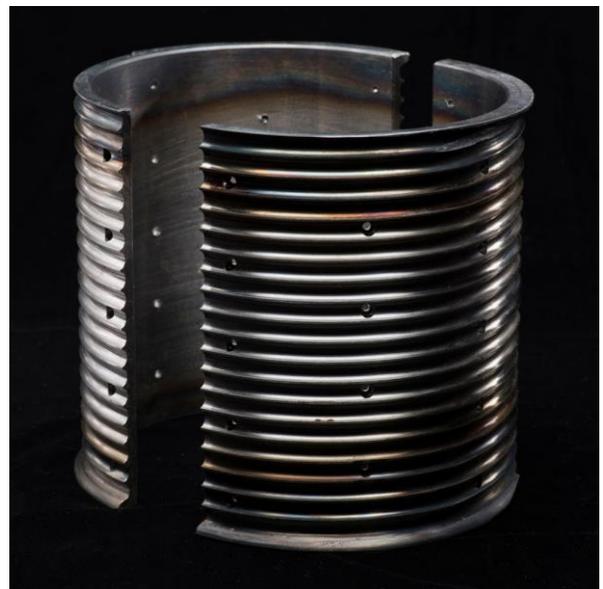
Source: 3D Industrial Engineering

Extend the life of wire rope by equipping winch drums with SpoolPro® Grooved Drums and Sleeves. SpoolPro®’s unique groove pattern allows wire rope to wind straight onto the drum (parallel to flanges) reducing wear on the rope, making it safer to use winch systems and limiting downtime. Follow [SpoolPro® on Facebook](#) for regular updates.

- Less time and labour needed to wind the rope onto the drum.
- Less man machine interaction, improving safety, and
- Reduced wear on the ropes, providing up to four months extra utilisation.

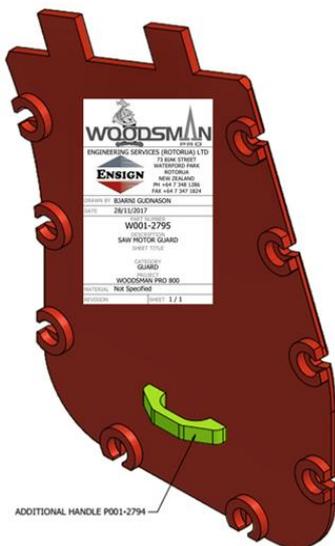
A qualified machine operator (a crew foreman) and the crew mechanic were lifting off the main saw box cover completing a routine task. They were trying to find a persistent oil leak in the processor head and had been working on the 800-series machine for approximately 2 hours. The cover (weighing 15kg) slipped from the operator’s left hand dropping onto his right-hand index finger.

Design fault – causing those completing maintenance to work in a manner that could cause injury. Unlike more recent models the 800-series machine did not have handles on its saw-box cover. Typically, screwdrivers would be used to lever off the saw-box cover (see – yellow arrow), then two people would manually lift it out and off, in this case using fingertips. Woodsman has subsequently produced a handle (see – green) for retro-fitting, [assembly instructions, a safety bulletin](#)¹ and a training package.

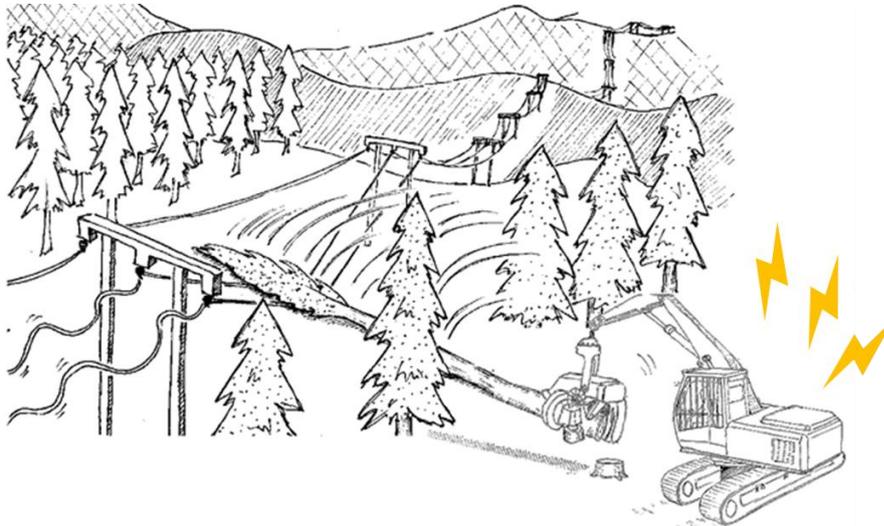
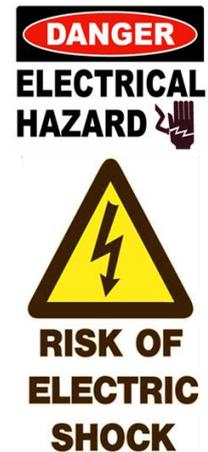
Description for Noggin INC511 31/10/17 – During mechanised felling a tree snapped off the stump and fell over live power lines leaving the live lines across a public road.

- Inadequate warning system – the fall hazard zone (FHZ) had not been marked.
- The ‘Live Line’ form (linked to the Company Safe Op) had not been correctly completed. Rather than working through the hierarchy of controls we accepted the Network Owner’s ‘Close Work Permit’ as a licence to operate without all appropriate controls in place.
- The Safe Op directs that the FHZ distance be measured by using the height of the tallest tree not the mean tree height, as in this case.
- Inadequate and untimely communications with the Network Operator – meaning that the lines could not be de-livened.
- The operator was also operating under ‘upset conditions’ thinking about a family member.

Live power lines are a hazard with high risk of serious injury or death, and anyone working around them must follow the Safe Op! Please also be aware that WorkSafe NZ has recently published its own guidance document – **A Practice Framework and Operational Guidance**².
