# PF Olsen Toolbox Safety Alert 36

<b>Date:</b> 13 October 2020	<b>Focus Group:</b> ATV Owners and Operators
<b>Topic:</b> ATV Use and PCBU Interactions	<b>Issued by:</b> Craig Fisher and Lawrie Scott

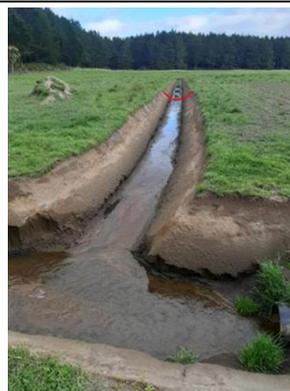
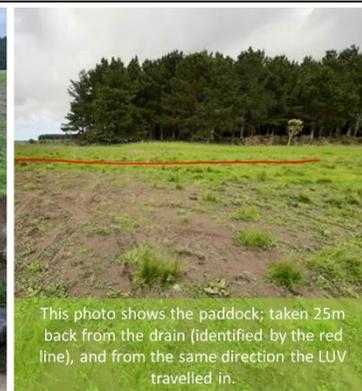
**Background and Incident:** Two pest control workers were shooting from a Light Utility Vehicle – an ATV – on a flat farm forest property. They had been on-site previously and were aware of the hazards, however, they were ‘spot-lighting’ – using a ‘red light’, which greatly reduced visibility. At 9:00pm they drove head-on into a 1-metre deep ditch, which was unmarked and hard to see in the long grass at night (see images).

This photo shows the paddock; taken 25m back from the drain (identified by the red line), and from the same direction the LUV travelled in.

**Safe Behaviours:** Our [Safe Op – All Terrain Vehicles \(ATV\)](#) in regard to S. 34 of the [HSW Act 2015](#) requires that the PCBU's “... pre-assess the tracks ... and travel areas” and “... agree on which sections may be used or not-used and record/mark such on the prescription map” along with any “... special hazards or conditions.” Such PCBU discussions should be well arranged and conducted in advance of operations. While operating an ATV at night for pest control purposes is permissible, shooting must only take place from a stationary vehicle. Additionally, operators/passengers must ensure that seatbelts, helmets, and safety boots are worn at all times when operating an ATV.
