BOOM! Don't Light Up! – Update

Access/Egress Incidents Increasing!

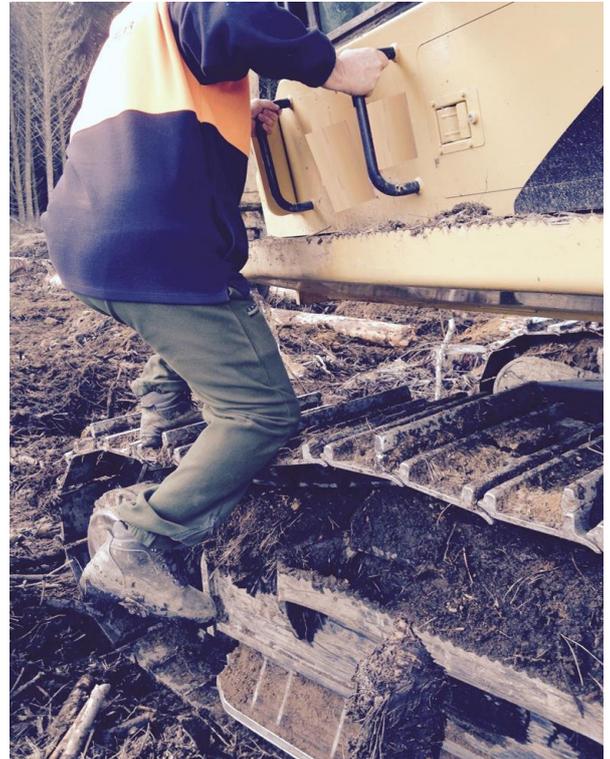
Climbing into or out of a cab – follow the checklist!

- ✓ Maintain 3 points of contact while climbing.
- ✓ Face the machine when climbing or dismounting.
- ✓ Monitor the state of the ladder (e.g., ice, mud, water, oil ...) and clean if necessary.
- ✓ Do not jump from a machine.
- ✓ Do not use either the steering wheel or any control lever.
- ✓ Do not climb off a moving machine.
- ✓ Align the cab with the undercarriage centreline – as appropriate.

A review of our newest machines shows a high degree of manufacturer innovation around footholds, handgrips and ladder devices. However, some older machines are deficient in this respect! Apart from keeping older machines clean, please consider how to improve machine access, perhaps by retrofitting some of these latest innovations.
